# Manhole Inspection Summary

Manhole # S33M1\_028MH

Insp Date: **3/24/08 2:08 PM**

**Location** Address: **201 Cherry Hill Bridge View**

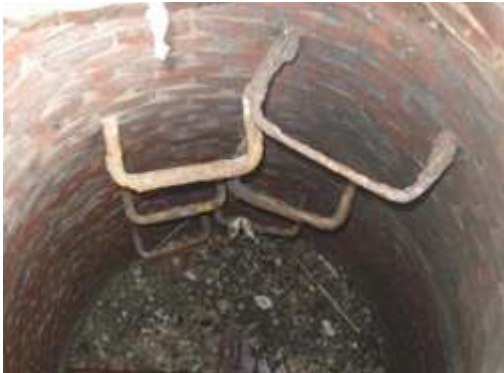
Steps

Count: **7** Missing: **0** ☐ Corroded

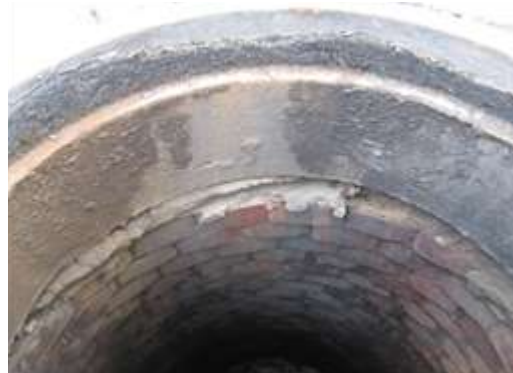
Defect 1

Offset: **1** (in.)

Frame Offset

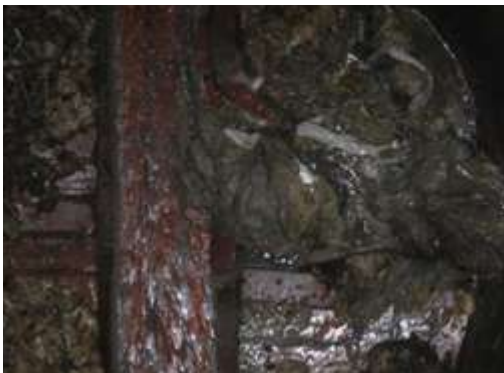
Defect 2

Condition: ☐ Sound ☐ Cracked ☐ Root Intrusion ☐ Deteriorated ☐ Leaks ☒ **Debris**

Debris

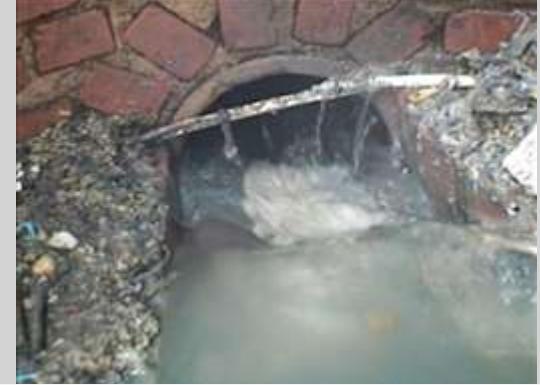
12 O'Clock Outflow

10 in. Circular Gravity Sewer  
Pipe Out @ 12 O'Clock

Pipe Height: **10.8** (in.) Rod and Bar (Angled)  
Pipe Material: **Clay** ☐ Pipe Lined  
Invert Depth: **11.96** (ft.) Flow Characteristics: **Fast**  
Deposits: ☒ None ☐ Mud ☐ Sludge ☐ Debris ☐ Grease  
Silt Depth: (in.) Deposits Extent:  
Infiltration: **None** Pipe Seal Cond: **Sound**

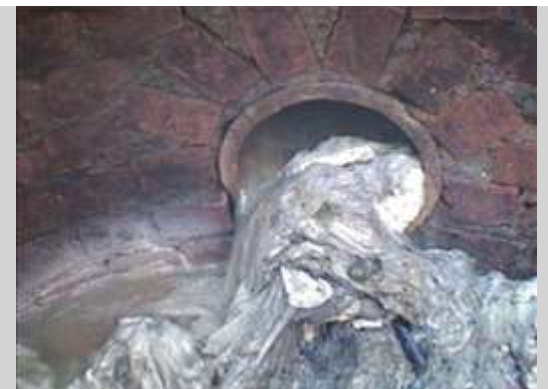
3 O'Clock Inflow

8 in. Circular Gravity Sewer  
Pipe In @ 3 O'Clock

Pipe Height: **8.4** (in.) Rod and Bar (Angled)  
Pipe Material: **Clay** ☐ Pipe Lined  
Invert Depth: **10.57** (ft.) Flow Characteristics: **Slow**  
Deposits: ☐ None ☐ Mud ☐ Sludge ☒ **Debris** ☐ Grease  
Silt Depth: **6** (in.) Deposits Extent: **Heavy**  
Infiltration: **None** Pipe Seal Cond: **Sound**

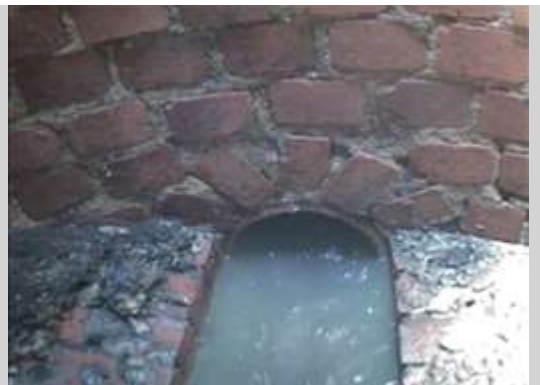
6 O'Clock Inflow

8 in. Circular Gravity Sewer

Pipe In @ 6 O'Clock

Pipe Height: **8.4** (in.) Rod and Bar (Angled)

Deposits: ☒ None ☐ Mud ☐ Sludge ☐ Debris ☐ Grease
